Property: 3401 Quebec (Q34)

Dated, underperforming office property

Cost effectively repair/enhance/update exterior to reposition the asset for better lease/sale performance

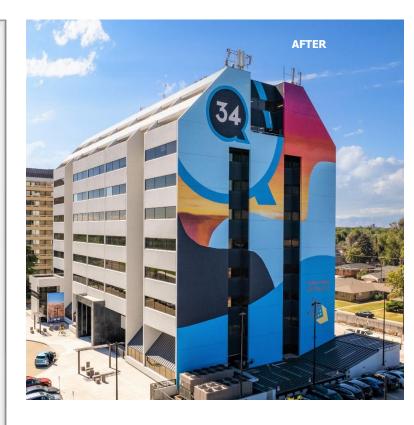
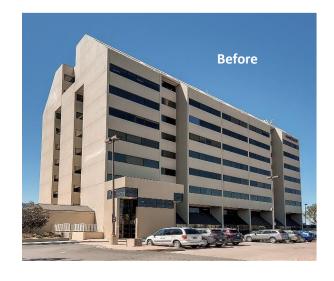
- 132,000 sf Office Built in 1975
- Aging and deteriorating exterior finishes
- Paint, concrete & sealant degradation

- Damaged concrete patched & repaired
- Concrete patio floors refinished with urethane deck coating
- Joint sealants replaced
- Concrete panels primed & sealed to protect from moisture & continued degradation
- Elastomeric coatings to provide modern/updated appearance & protection from the elements
- Hand painted mural applied
